DEPARTMENT OF NATURAL RESOURCES
DIVISION OF OIL, GAS AND MINING

RE: Site Inspection, ECDC Environmental, LC., ECDC Clay Mine, M/015/062, Emery County, Utah

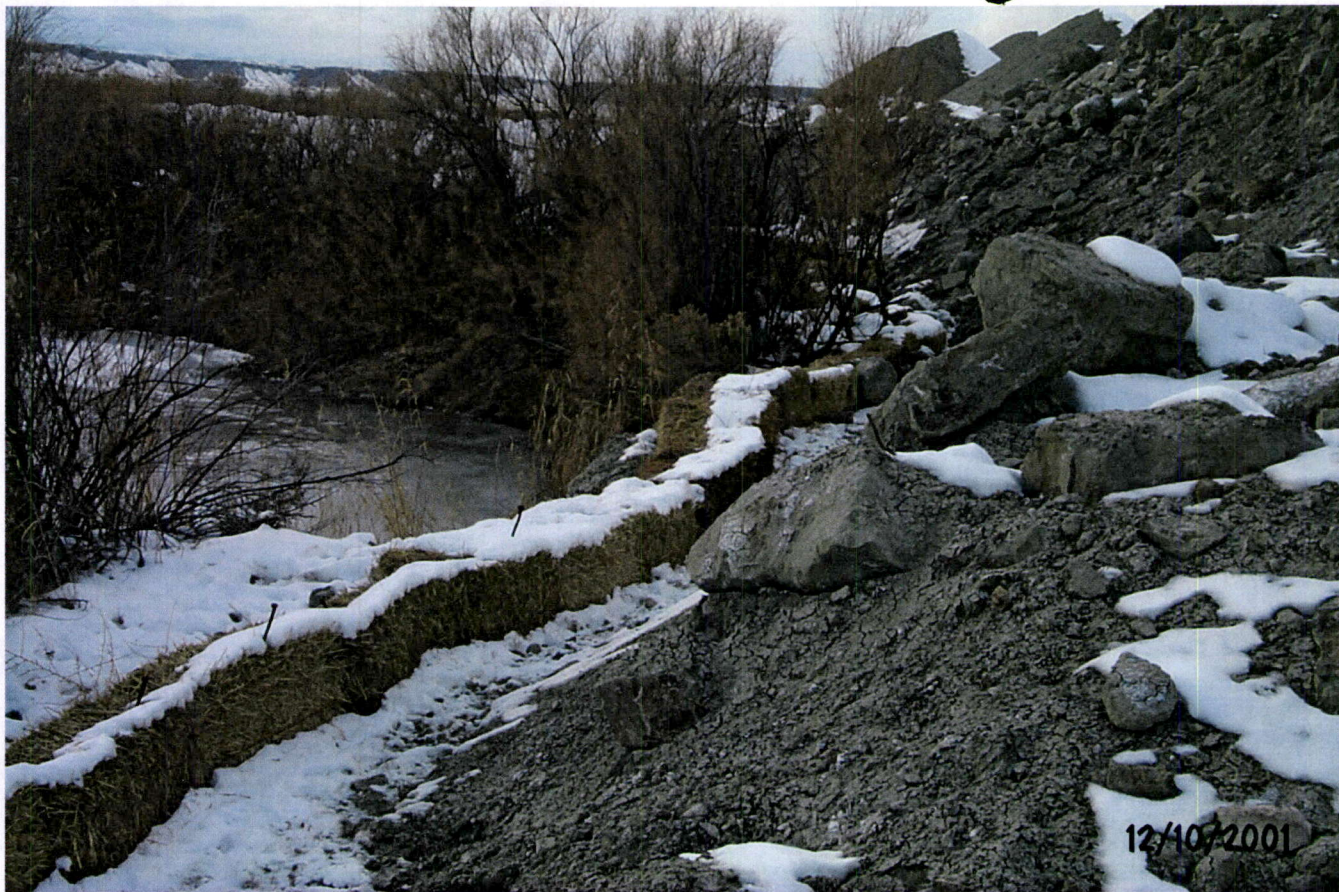
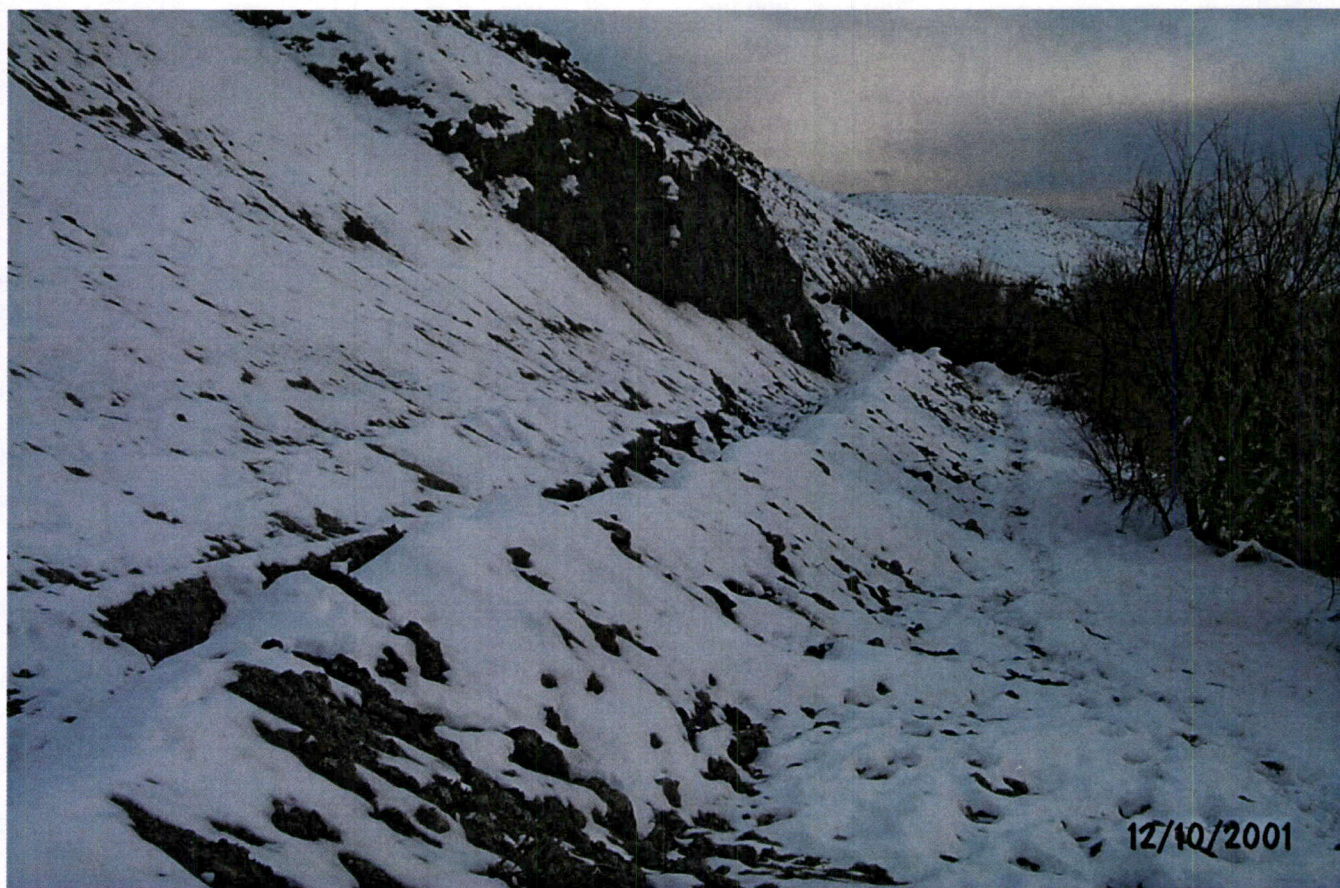
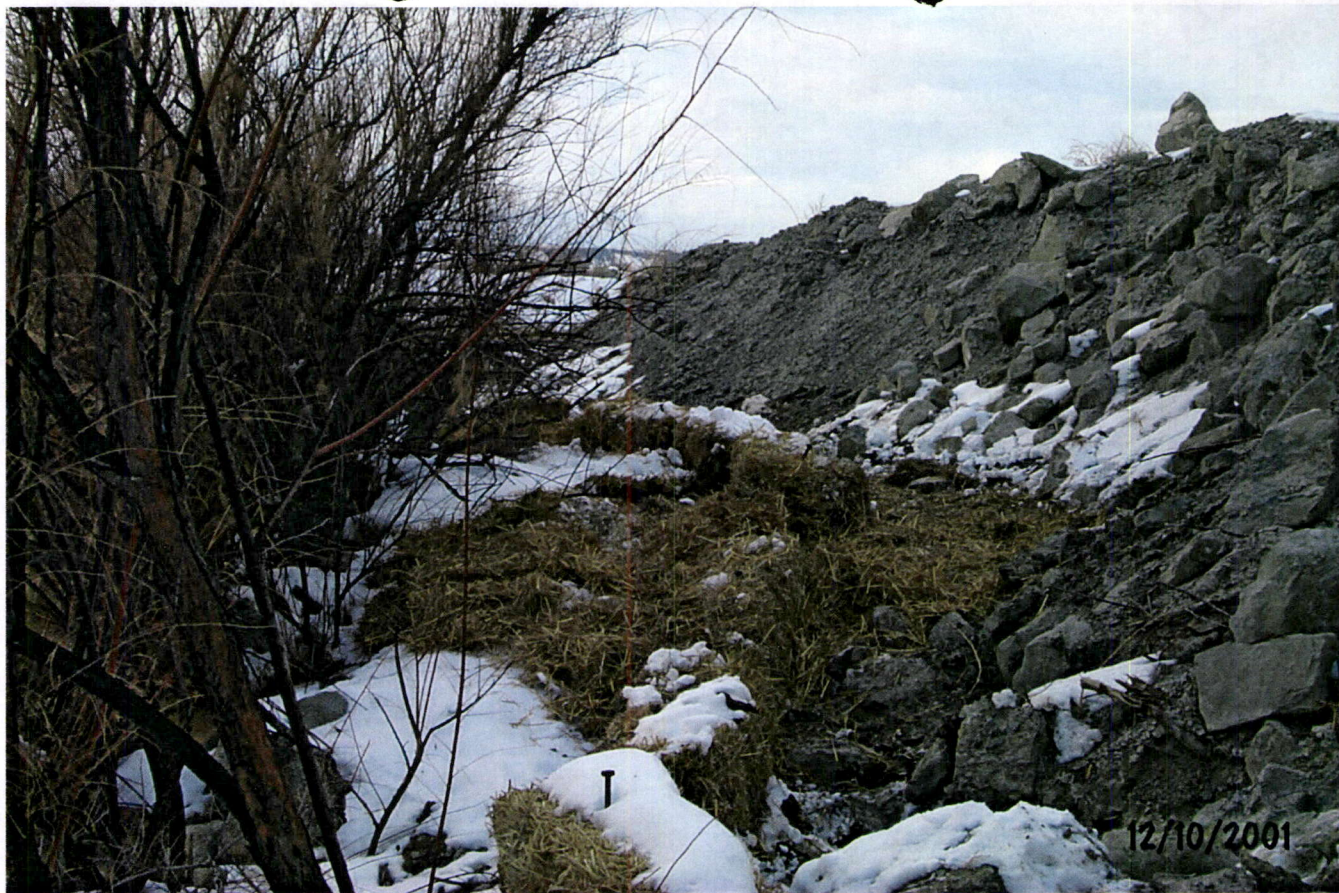
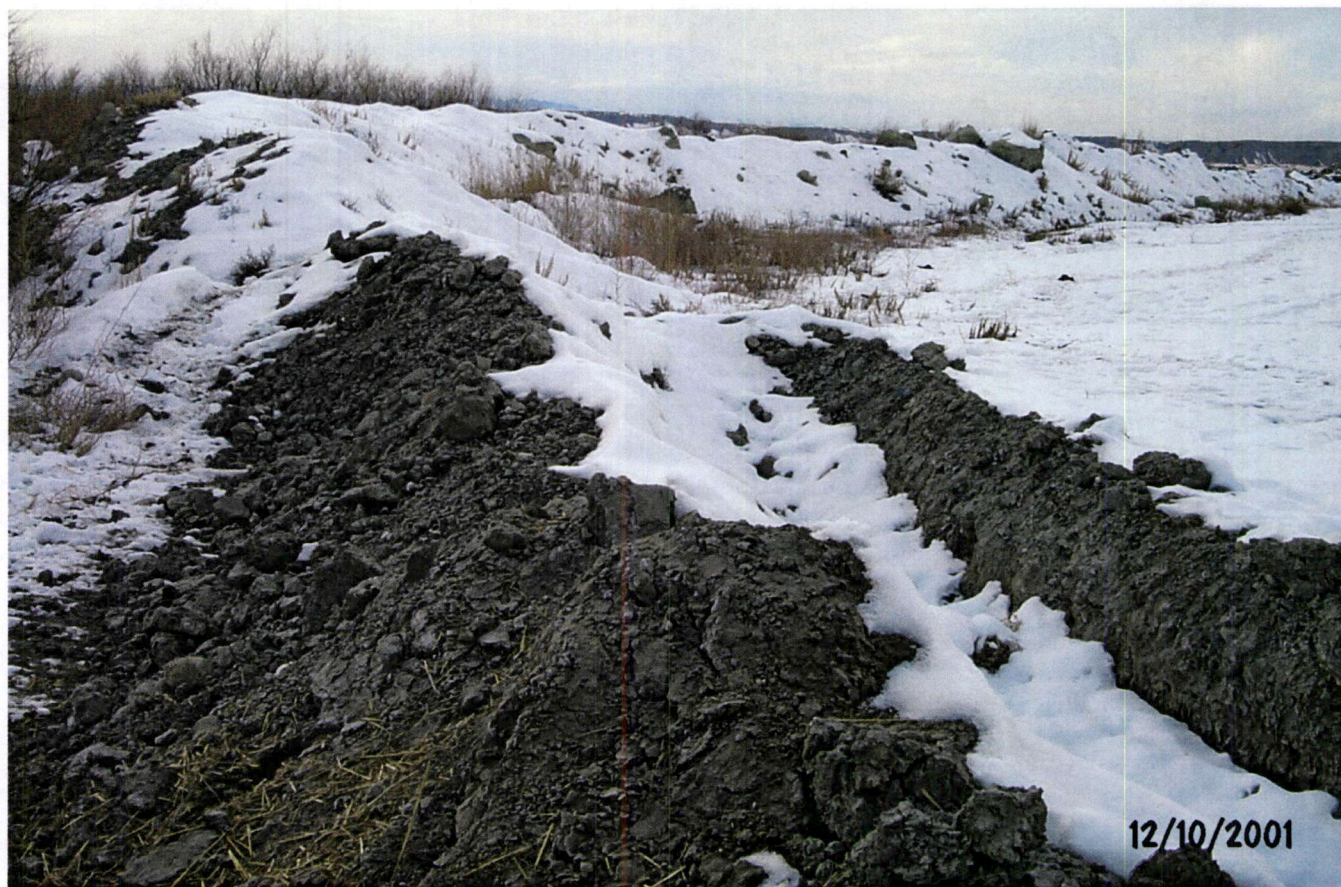
All of the work to control runoff and sediment that I previously requested has been done. From the sharp bend in the river toward the southeast, the operator has installed a berm that should be effective in keeping runoff water from getting to the Price River. Mr. Olson said the area between the berm and the river was seeded, but because of the snow, I couldn't confirm this.

A row of straw bales has been placed between the waste/spoil pile and the river. These straw bales are anchored with roof bolts. A few of these bales have been broken, but the row of straw bales should still be effective. About five head of cattle were in the area during the inspection, and I assume they were responsible for breaking the bales.

A trench and a berm have been installed just west of the spoil/waste pile, and this should keep runoff from reaching the Price River. Farther west near the gate, two culverts have been cleaned, and the operator has installed several straw bales on the edge of the road above the outlet to the lower culvert.

The attached photos show the berms and straw bales.

A few straw bales will need to be replaced, and all of the bales will need to be maintained. I was pleased with the work the operator has done.
